**Government of the Kingdom of Swaziland
Ministry of Natural Resources and Energy
Department of Water Affairs**

**Water & Sanitation Point
Mapping Pilot Project**

REPORT 2012

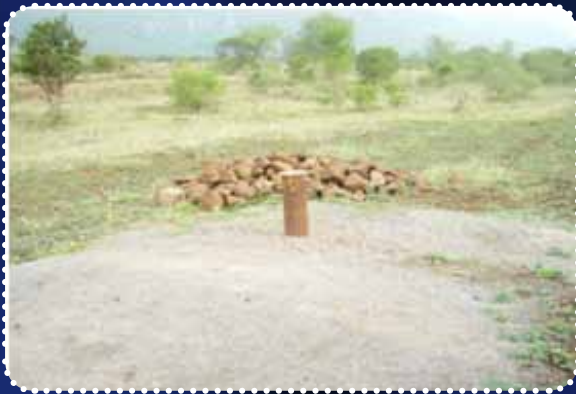
1. Drilled bore hole at mbagave community under mkhiweni inkhundla

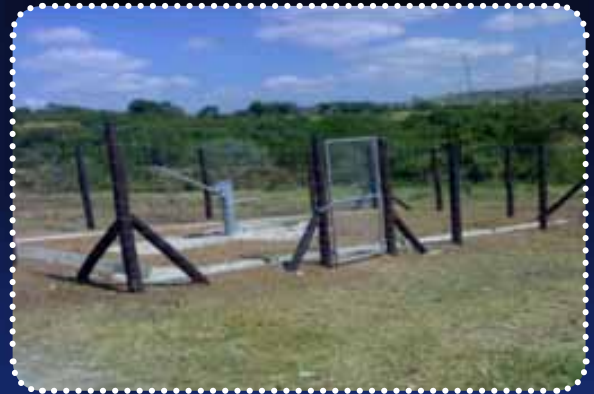
2. Manyandela handpump under mkhiweni inkhundla

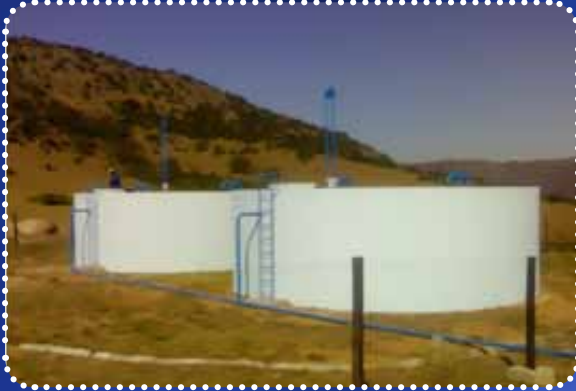
3. Reservoirs at sivumelwano lesisha community water in manzini region

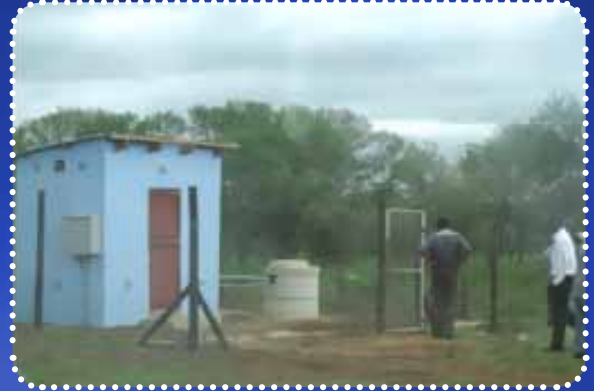
4. Control house at luvu community water project under mtfogwaneni inkhundla

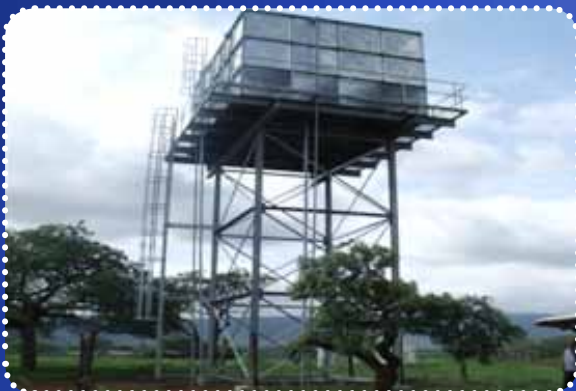
5. Becker elevated steel panel reservoirs at ndzevane rural water supply scheme

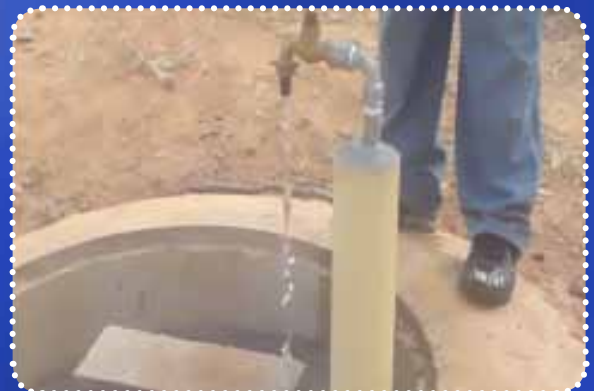
6. Stand pipe (siphofaneni umzabalazo wabomake water project)

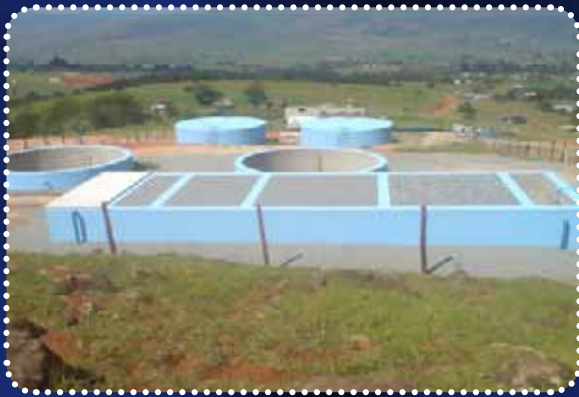
7. Lamgabhi water project treatment works

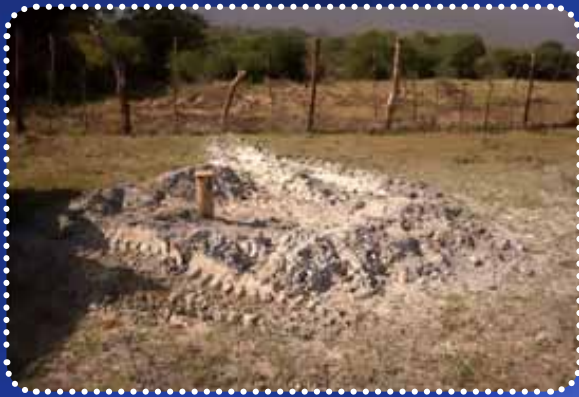
9. Monitoring well

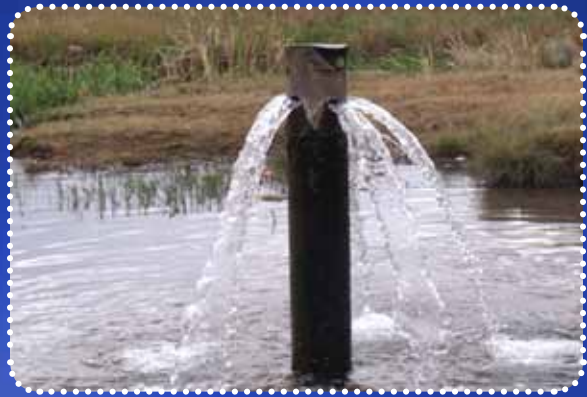
10. Artesian well at fosini community

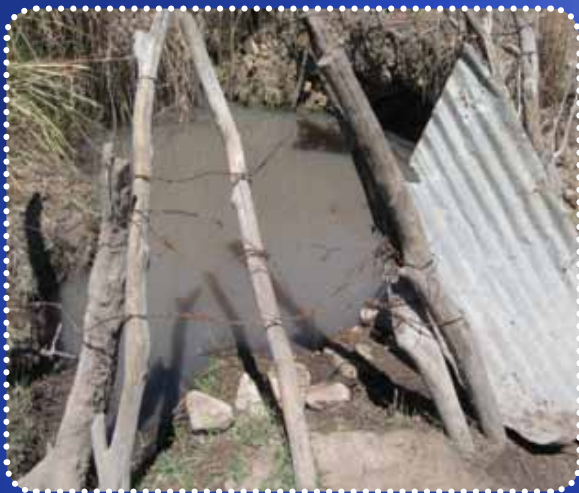
*11. Unprotected spring- tikhuba mvubetse community
Matsanjeni inkhundla*

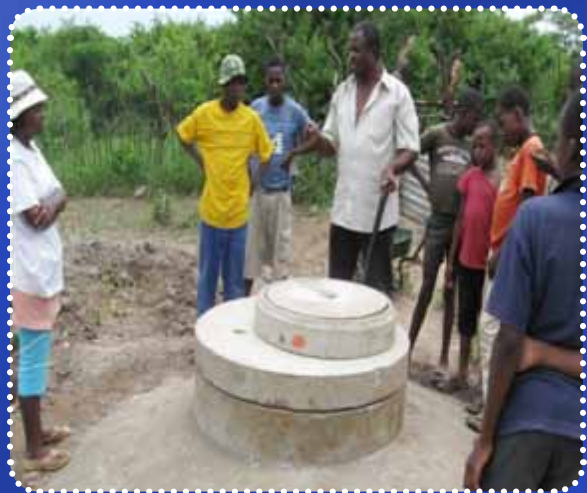
12. Spring protection

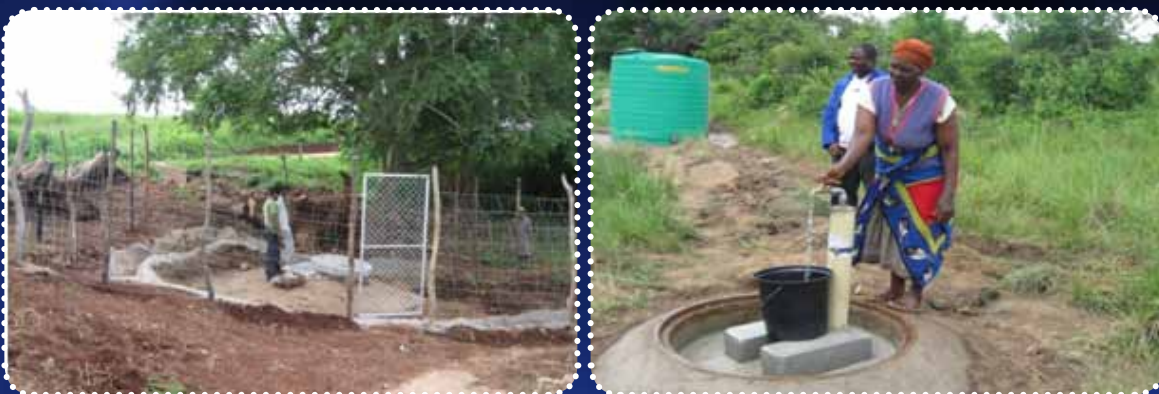
13. Completed spring protection maphungwane community

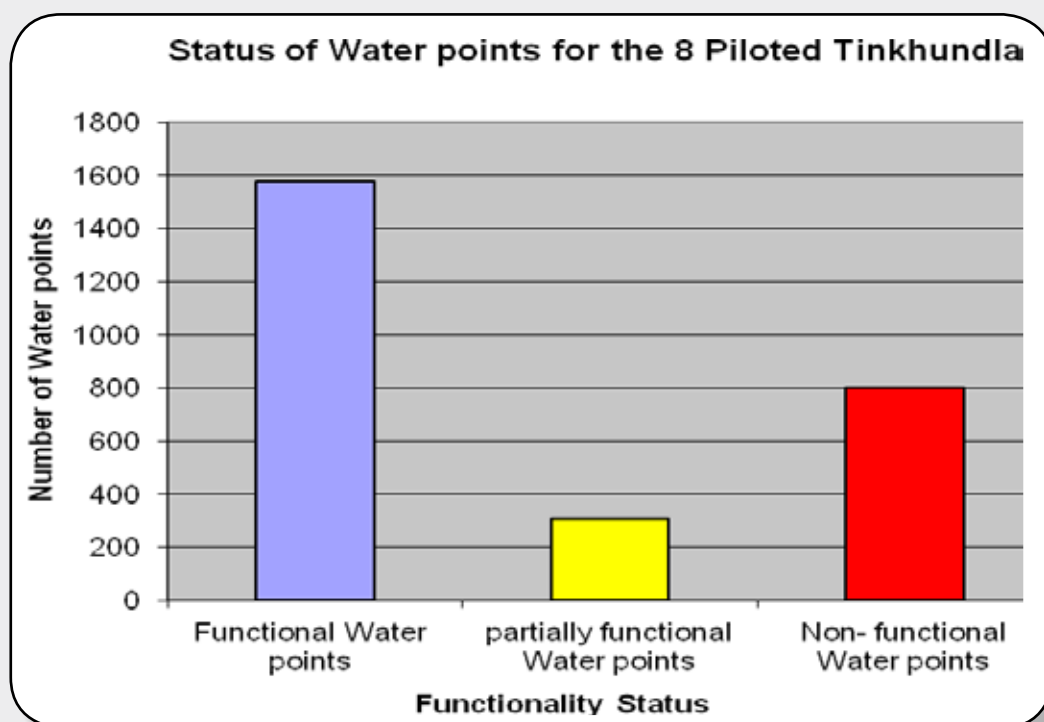
Graph 1 Summary of Findings – Status of Water Points for the 8-Piloted Tinkhundla

Table 1 and graph 1 above presents the total number of water points mapped in the 8 Tinkhundla. The table also presents total number and percentages of functional, partially functional and non-functional of water points mapped.

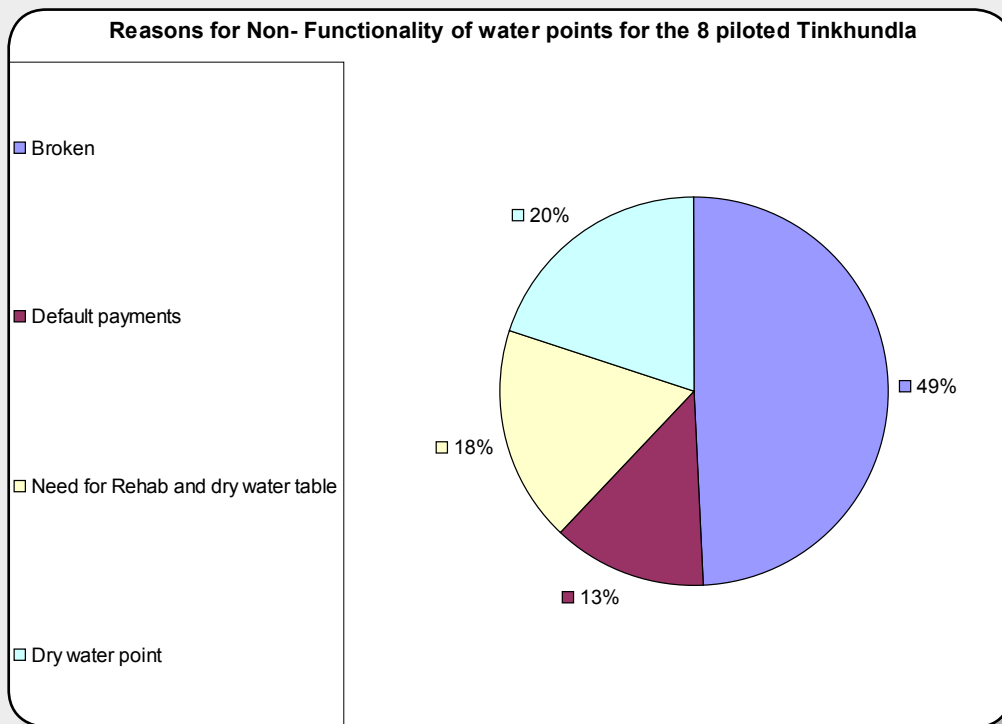
Pie Chart 1 above shows some of the reasons for non-functionality of mapped water points in the 8 Tinkhundla. The pie chart shows that 49% of water points were broken, 13% default payment, 18% need for rehabilitation and dry water table, 20% dry water points and 20% other reasons . However, broken systems and dry water points may also require rehabilitation. These results may be used to further investigate the total number of water points that requires rehabilitation possible draw up a rehabilitation budget.

Other reasons for nonfunctionality includes, (Burnt, blocked pipe, poor connection, abandoned, collapsed borehole, undeveloped borehole, yield too low, pump not installed, licking reservoirs, mono pump non functional, poor connections, vandalism etc).

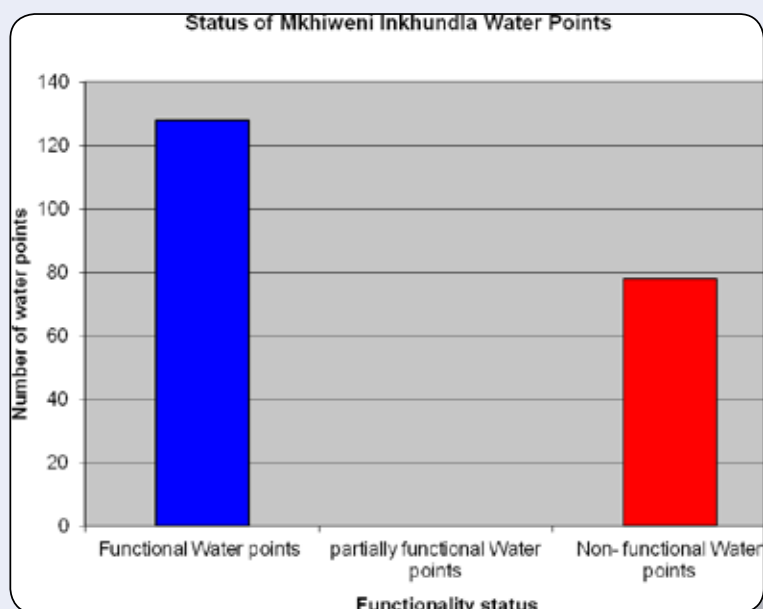
Graph 2 Presents Summary of Findings – Status of Mkhiweni Inkhundla Water Points

Graph 2 above shows the number of functional, partially functional and non-functional water points at Mkhiweni Inkhundla. The graph indicates that the total number of functional water points is 128 (62.14%) while 78 (37.86%) water points were non-functional. The list of non-functional water points that requires rehabilitation in the Mkhiweni Inkhundla are listed in Table 4-A and 4-B below.

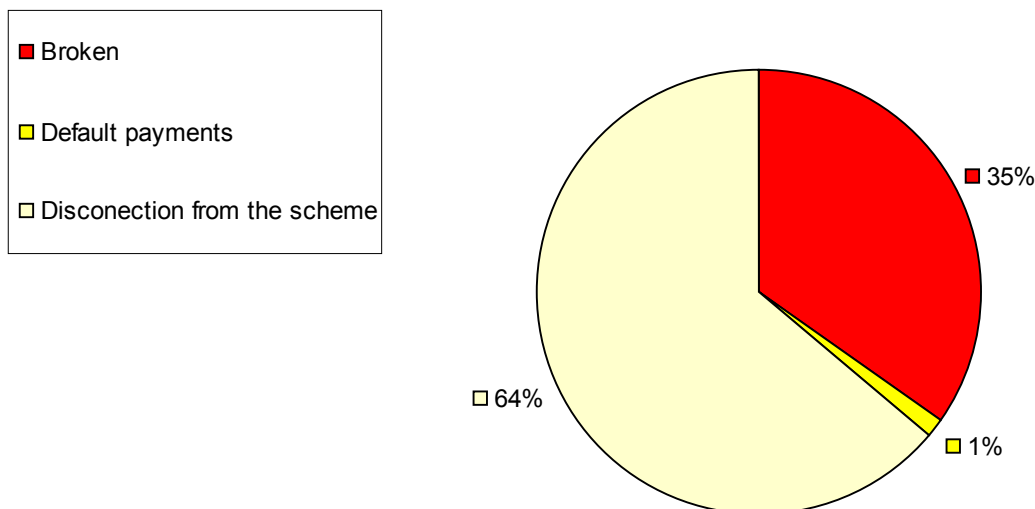
Pie Chart 2 Reasons for Non-Functionality of Mkhiweni Inkhundla Water Points

The pie chart 2 above shows the reasons for non-functionality of water points at Mkhiweni Inkhundla. The pie chart depicts that 35 % of the water points were broken, 1% default payment of electricity and 64% was disconnection from the scheme. The findings of this mapping exercise under this constituency shows that 35 % of the water points are broken and those broken are listed in Table 4-A and Table 4-B.

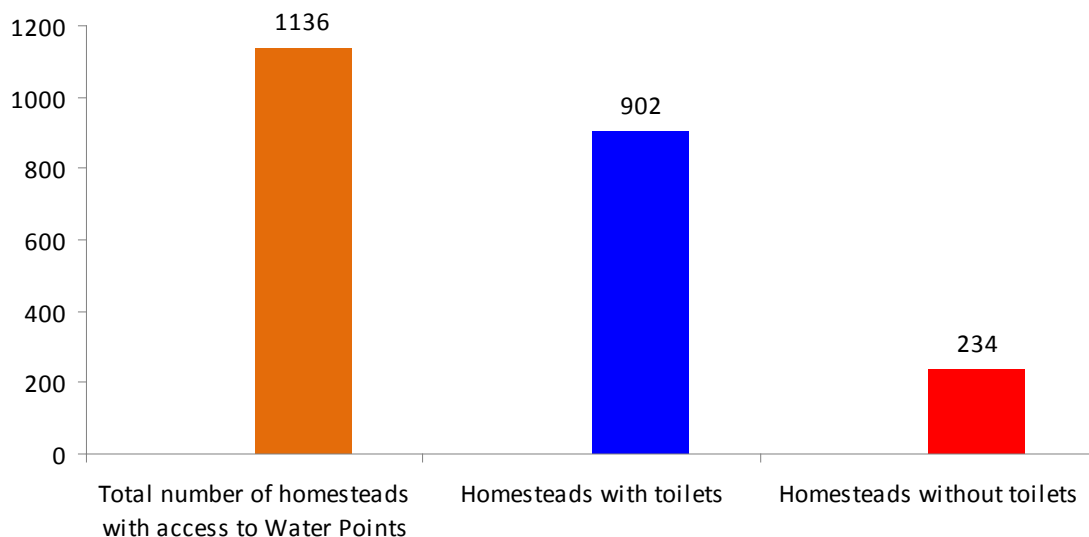
Graph 3 Presents Mkhiweni Inkhundla Sanitation Coverage by homesteads

Graph 3 above shows the total number of homesteads at Mkhiweni Inkhundla with access to water points and number of homesteads with toilets and number of homesteads without toilets. The data show that there are still homesteads without toilets at Mkhiweni Inkhundla out of those sampled during this exercise.

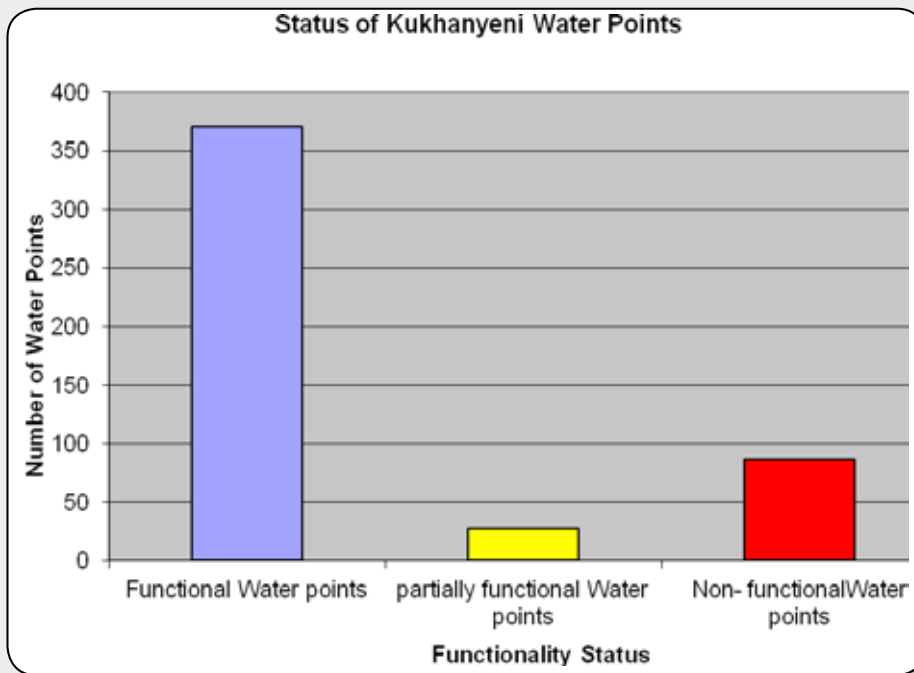
Graph 4 Presents Summary of Findings – Status of Kukhanyeni Inkhundla Water Points

Graph 4 above indicates the number of functional, partially functional and non-functional water points at Kukhanyeni Inkhundla. The graph shows that the total number of functional water points is 371 (76.34%), total number of partially functional water points is 28 (5.76%) and 87 water points were non-functional (17.9%).

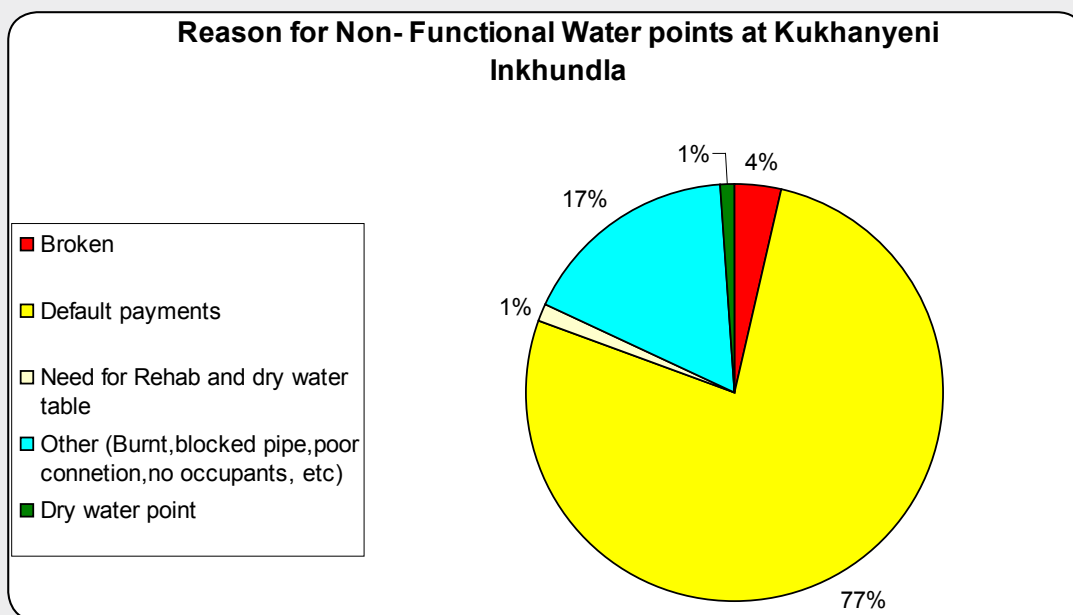
Pie Chart 3 Reasons for Non-Functionality of Kukhanyeni Inkhundla Water Points

The pie chart 3 above shows the reasons for non-functionality of water points at Kukhanyeni Inkhundla. The pie chart depicts that 4% of the water points were broken, 77% default payments (Electricity), 1% need rehabilitation and dry water table, 1% for dry water point and 17% for other reasons. Mkhulamini water scheme is one of the reticulated schemes under this constituency that requires rehabilitation as this project had exceeded its design period and this was determined by the findings of mapping exercise. Two hand pumps under Mbuluzana community also require full rehabilitation. Detailed list of water points that requires rehabilitation under this Inkhundla are listed on Table 4A and Table 4 B below.

Default Payment means that the community fails to pay electricity bill and the water point has been disconnected.

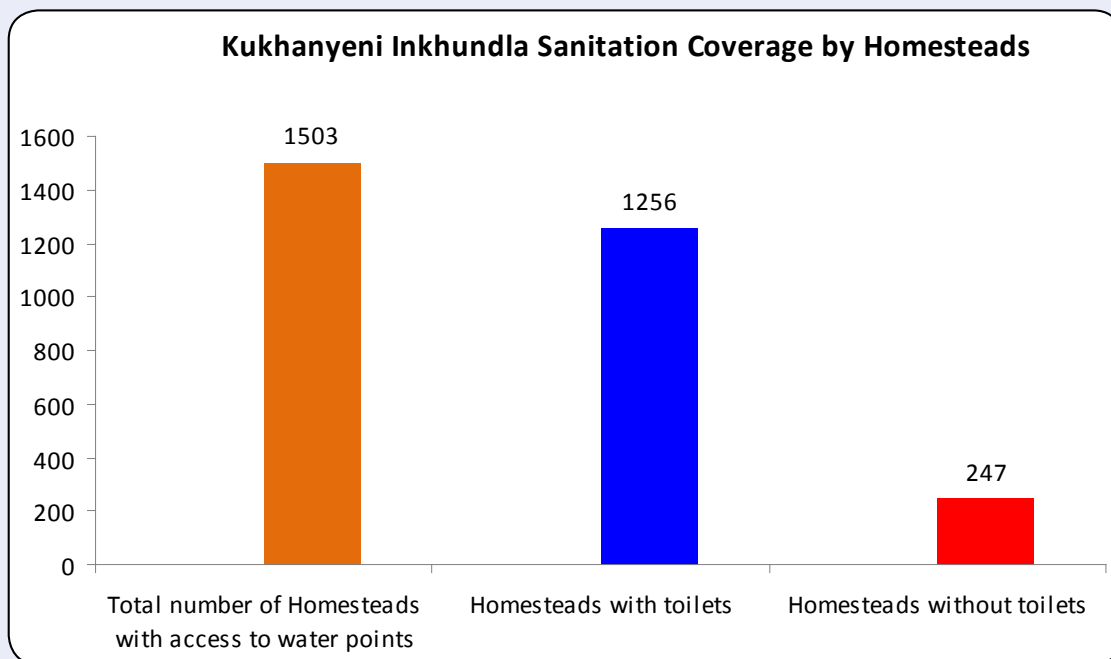
Graph 5 Presents Kukhanyeni Inkhundla Sanitation Coverage by homesteads

Graph 5 above shows the total number of homesteads at Kukhanyeni Inkhundla with access to water points and out of 1503 total homesteads sampled, 1256 had toilets while 247 had no toilets. The data show that there are still homesteads without toilets at Khukhanyeni Inkhundla out of those sampled during this exercise.

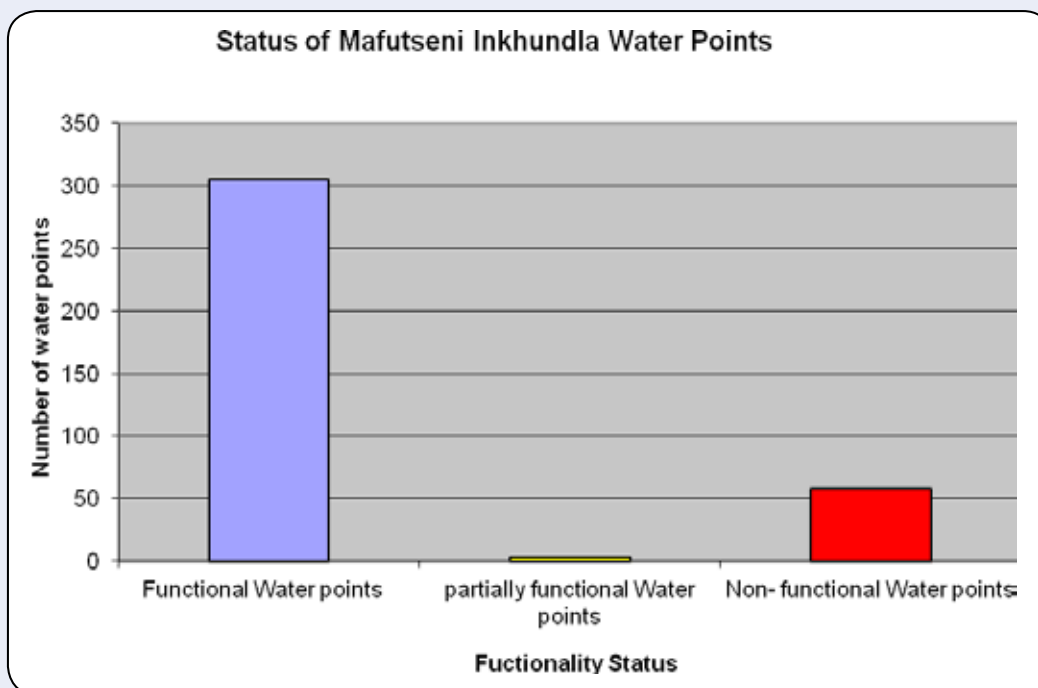
Graph 6 Presents Summary of Findings –Status of Mafutseni Inkhundla Water Points

Graph 6 above shows the number of functional, partially functional and non-functional water points at Mafutseni Inkhundla. The graph shows that the total number of functional water points is 305 (83.33%), total number of partially functional water points is 3 (0.82%) and 58 water points were non-functional (15.85%).

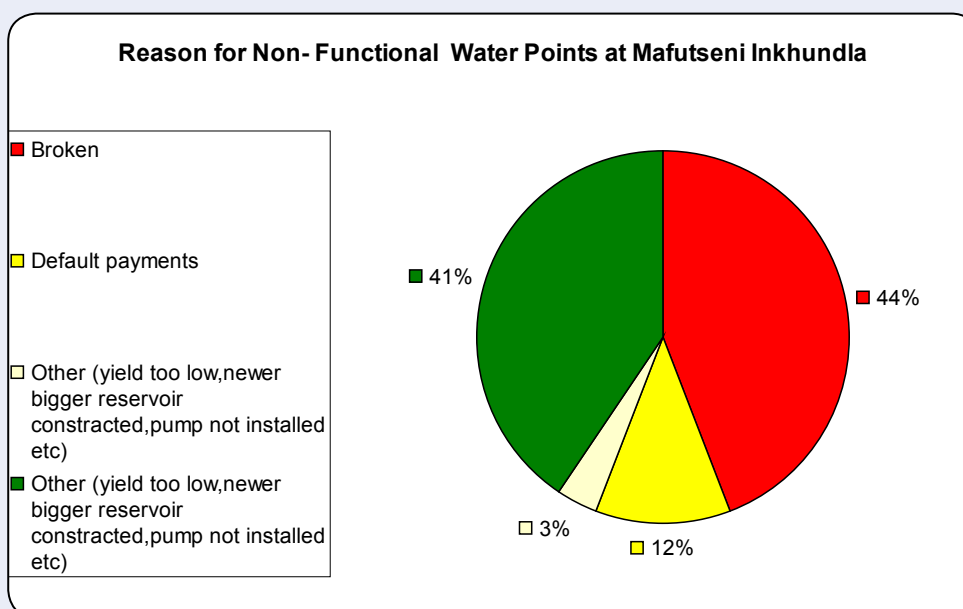
Pie Chart 4 Reasons for Non-Functionality of Mafutseni Inkhundla Water Points

The pie chart 4 above shows the reasons for non-functionality of water points at Mafutseni Inkhundla. The pie chart depicts that 44% of the water points were broken, 12% default payments, 3% need rehabilitation and dry water table and 41% for leaking reservoirs and other reasons. Through the findings of this mapping exercise under this Inkhundla 44% of the water points need rehabilitation and are listed on Table 4 A and B.

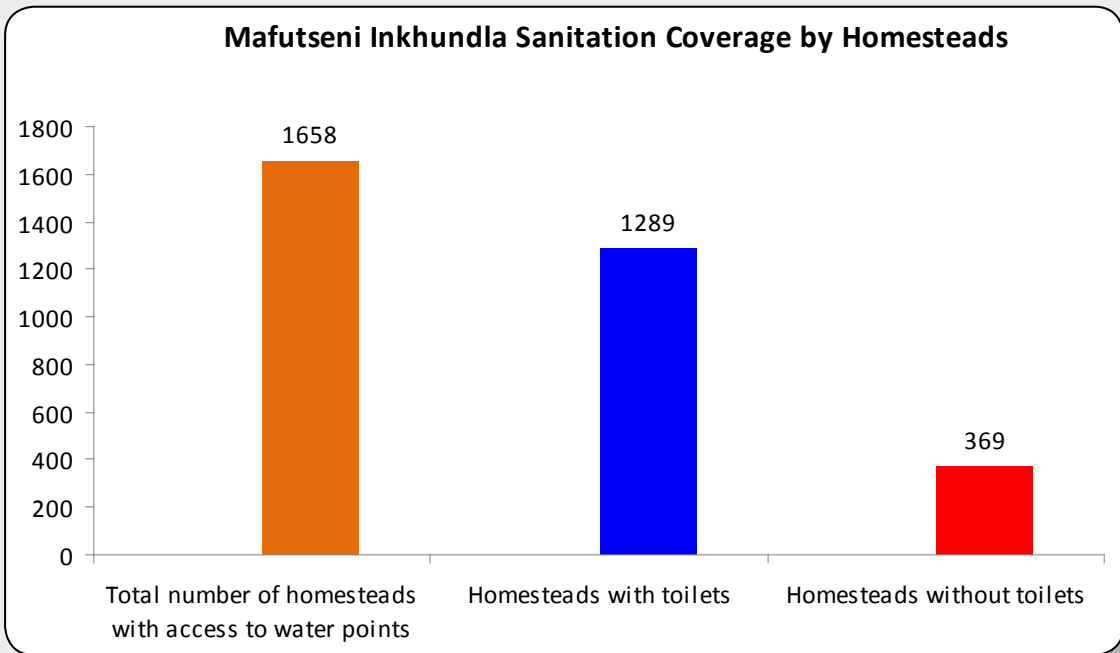
Graph 7 Presents Mafutseni Inkhundla Sanitation Coverage by homesteads

Graph 7 above shows that out of 1658 sampled homesteads, 1289 has toilets while 369 are without toilets. The results shows that there are homesteads with access to potable water but without an access to toilets. There is need for intervention to ensure that all the homesteads have access to toilets and proper sanitation facilities.

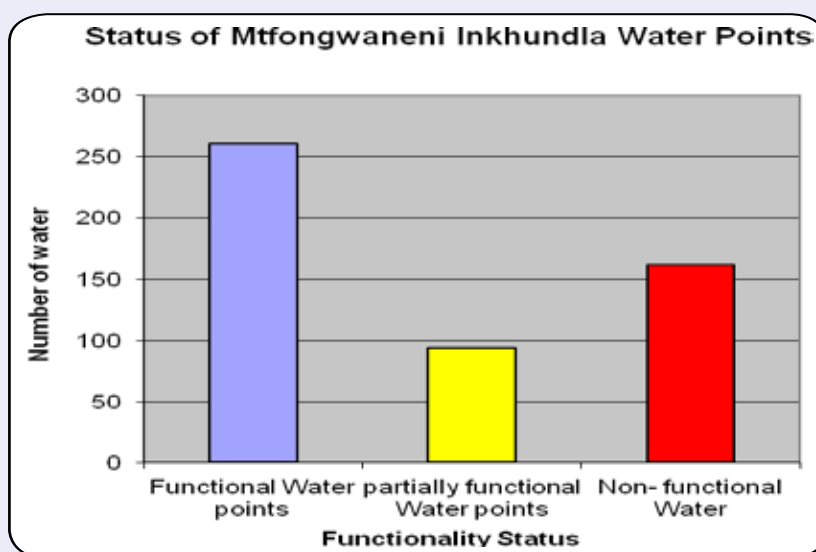
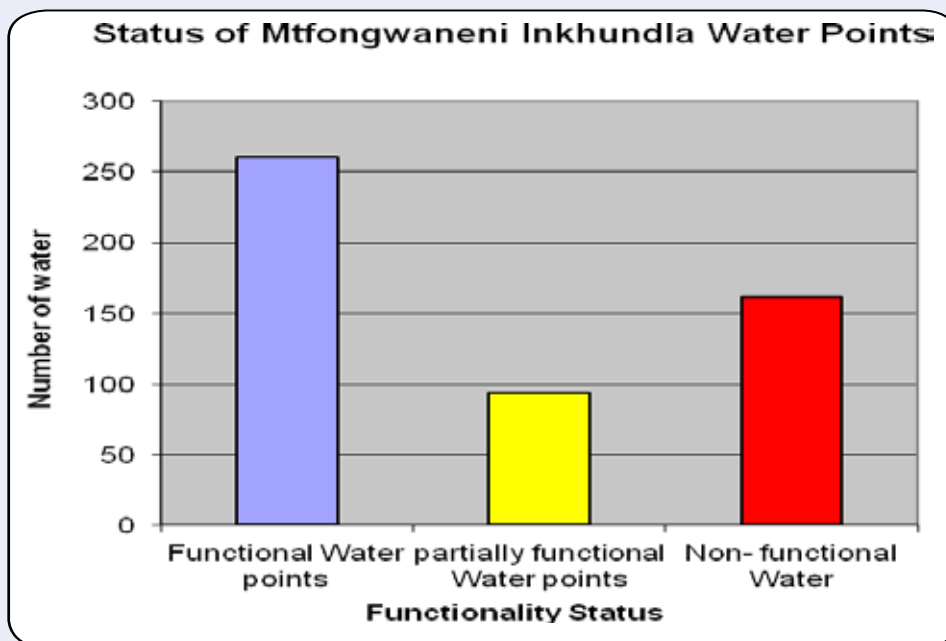
Graph 8 Presents Summary of Findings –Status of Mtfongwaneni Inkhundla Water Points

Graph 8 above shows the number of functional, partially functional and non-functional water points at Mtfongwaneni Inkhundla. The graph shows that the total number of functional water points is 261 (50.48%), total number of partially functional water points is 94 (18.18%) and 162 water points were non-functional (31.34%). Partially functional water points means that the water point does not serve the intended population in full. It may be rationed or sometimes dry etc.

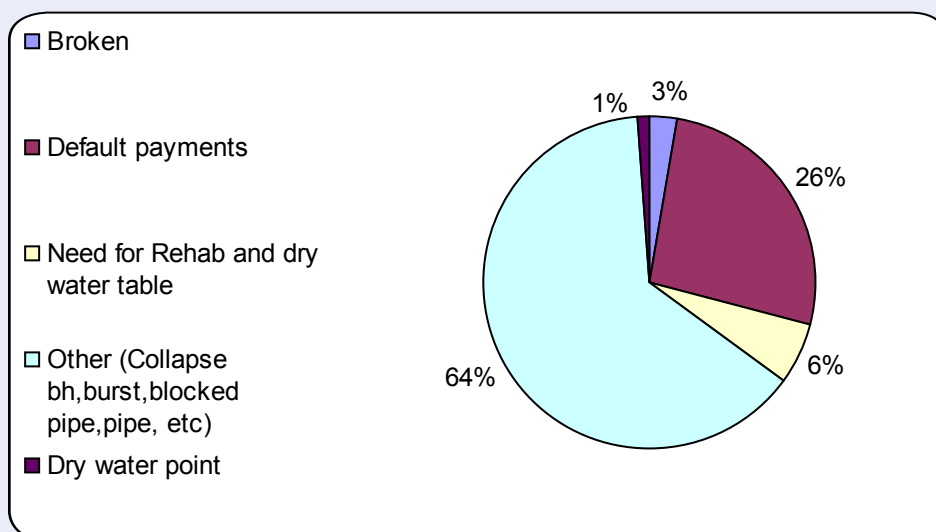
Pie Chart 5 Reasons for Non-Functionality of Mtfongwaneni Inkhundla Water Points

The pie chart 5 above shows the reasons for non-functionality of water points at Mtfongwaneni Inkhundla. The pie chart depicts that 3% of the water points were broken, 26% default payments, 6% need rehabilitation and dry water table, 1% for dry water point and 64% for other reasons. Through the findings of this mapping exercise under this constituency, 6% of the water points need rehabilitation and below is the list of the water scheme that require rehabilitation. The results shows that there is only 6% that needs rehabilitation, however even the 64% other may also need rehabilitation. A further study that will inform the necessary action to be taken on the default water points may be conducted.

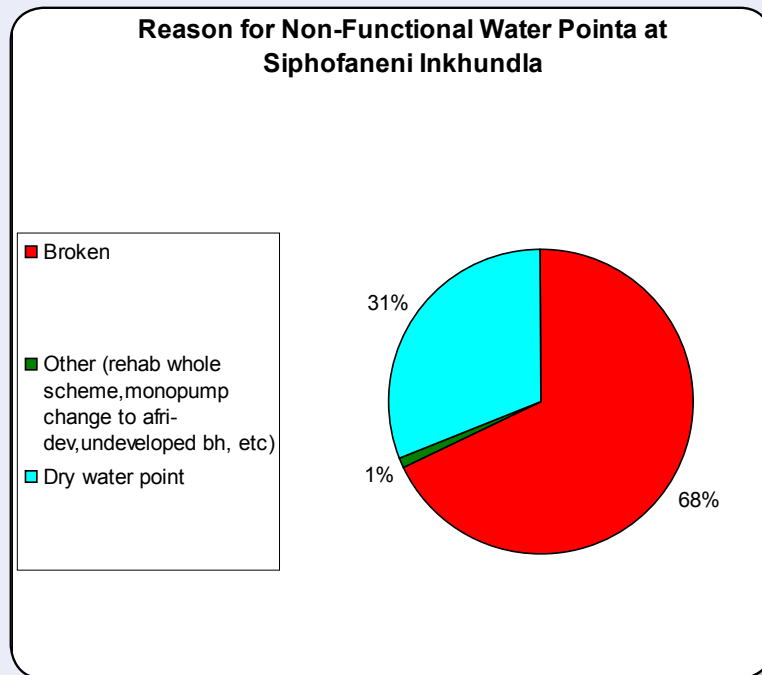
Pie Chart 6 Reasons for Non-Functionality of Siphofaneni Inkhundla Water Points Distribution

The pie chart 6 above shows the reasons for non-functionality of water points at Siphofaneni Inkhundla. The pie chart depicts that 68% of the water points were broken, 1% for dry water points and 31% illegal connection and other reasons. The results of this mapping exercise shows that 68% of the water points are broken and three (3) of these water points are macro schemes while (2) two of those schemes are micro schemes. The illegal connections lead to non-availability of water in other water points. The results show that only 68% of the non-functional schemes require rehabilitation; however a further study may be conducted to inform the required action on the other non-functional water points.

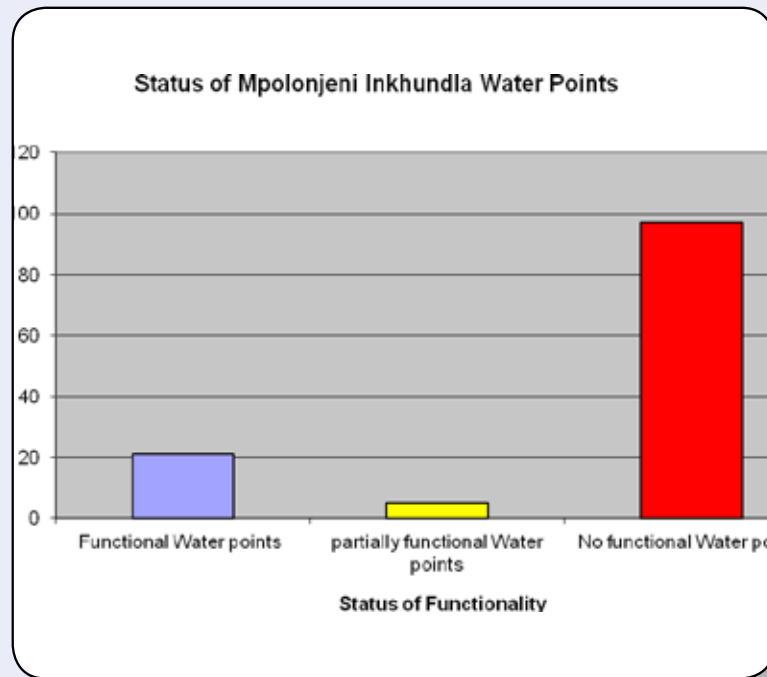
Graph 12 Presents Summary of Findings –Status of Mpolonjeni Inkhundla Water Points

Graph12 above shows the number of functional, partially functional and non-functional water points at Mpolonjeni Inkhundla. The graph shows that the total number of functional water points is 21 (17.07%), total number of partially functional water points is 5 (4.07%) and 97 water points were non-functional (78.23%).

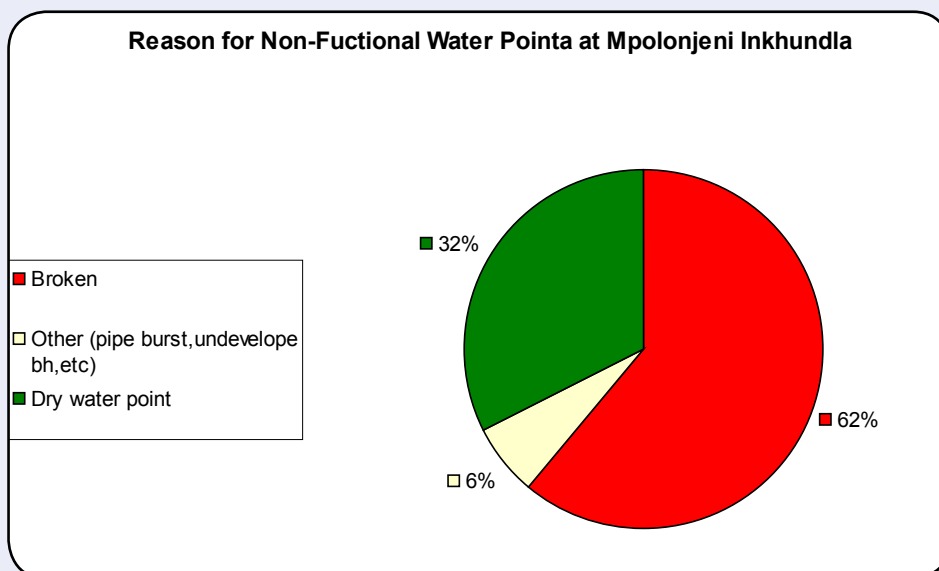
Pie Chart 7 Reasons for Non-Functionality of Mpolonjeni Inkhundla Water Points

The pie chart 7 above shows the reasons for non-functionality of water points at Mpolonjeni Inkhundla. The pie chart depicts that 61% of the water points were broken, 33% for dry water points and 6% for pipe burst and other reasons. According to the findings of this mapping exercise that 61% of the water points are broken and three (3) of these water points are macro schemes while (3) of those schemes are micro schemes shown on table 4-B.

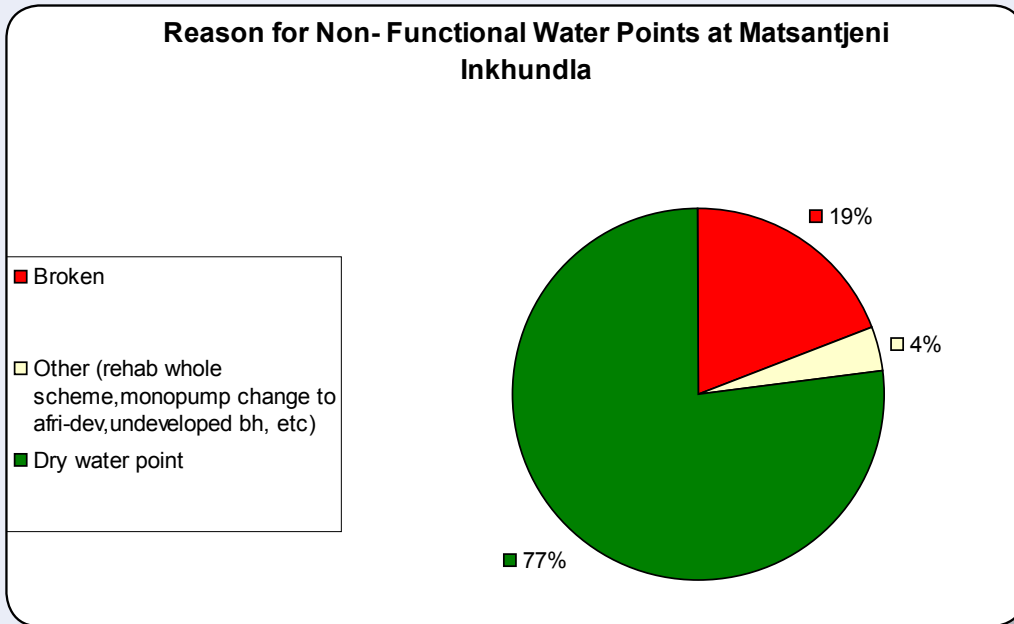
Pie Chart 8 Reasons for Non-Functionality of Matsanjeni North Inkhundla Water Points

The pie chart 8 above shows the reasons for non-functionality of water points at Matsanjeni North Inkhundla. The pie chart depicts that 19% of the water points were broken, 77% for dry water point and 4% for undeveloped borehole and other reasons. According to the findings of this mapping exercise as indicated above pie charts that 19% of the water points are broken and required rehabilitation under this constituency are listed on Table 4-B.

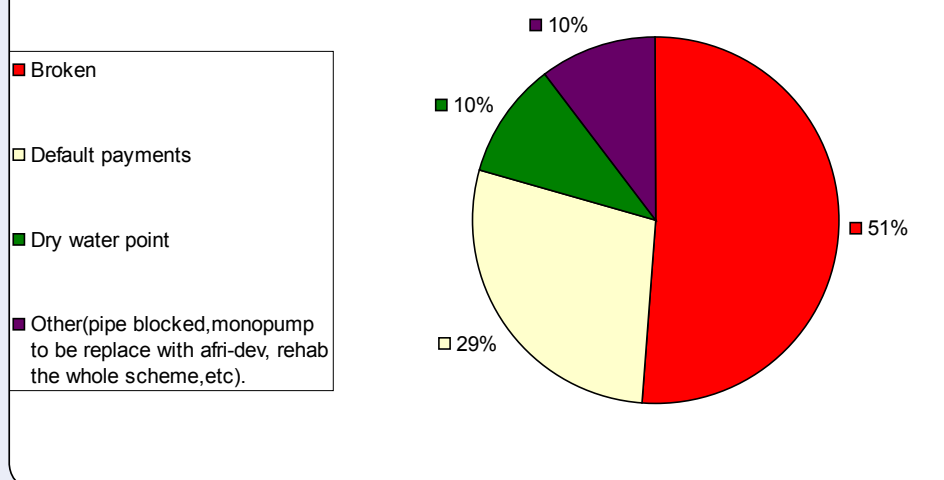
Pie Chart 9 Reasons for Non-Functionality of Lugongolweni Inkhundla Water Points

The pie chart 9 above shows the reasons for non-functionality of water points at Lugongolweni Inkhundla. The pie chart depicts that 51% of the water points were broken, 29% for default payments, 10% for dry water point and 10% for pipe blocked and other reasons. Vukamatsetsa community water project and Maphatsindvuku water scheme are two of the reticulated schemes under this constituency that requires a major rehabilitation as these projects had exceeded its design period as determined by the finding of mapping exercise.
